GMD SHIPYARD CORP.

22 September 2014

Re: GMD Shipyard Administrative Compliance Order CWA-02-2014-3050

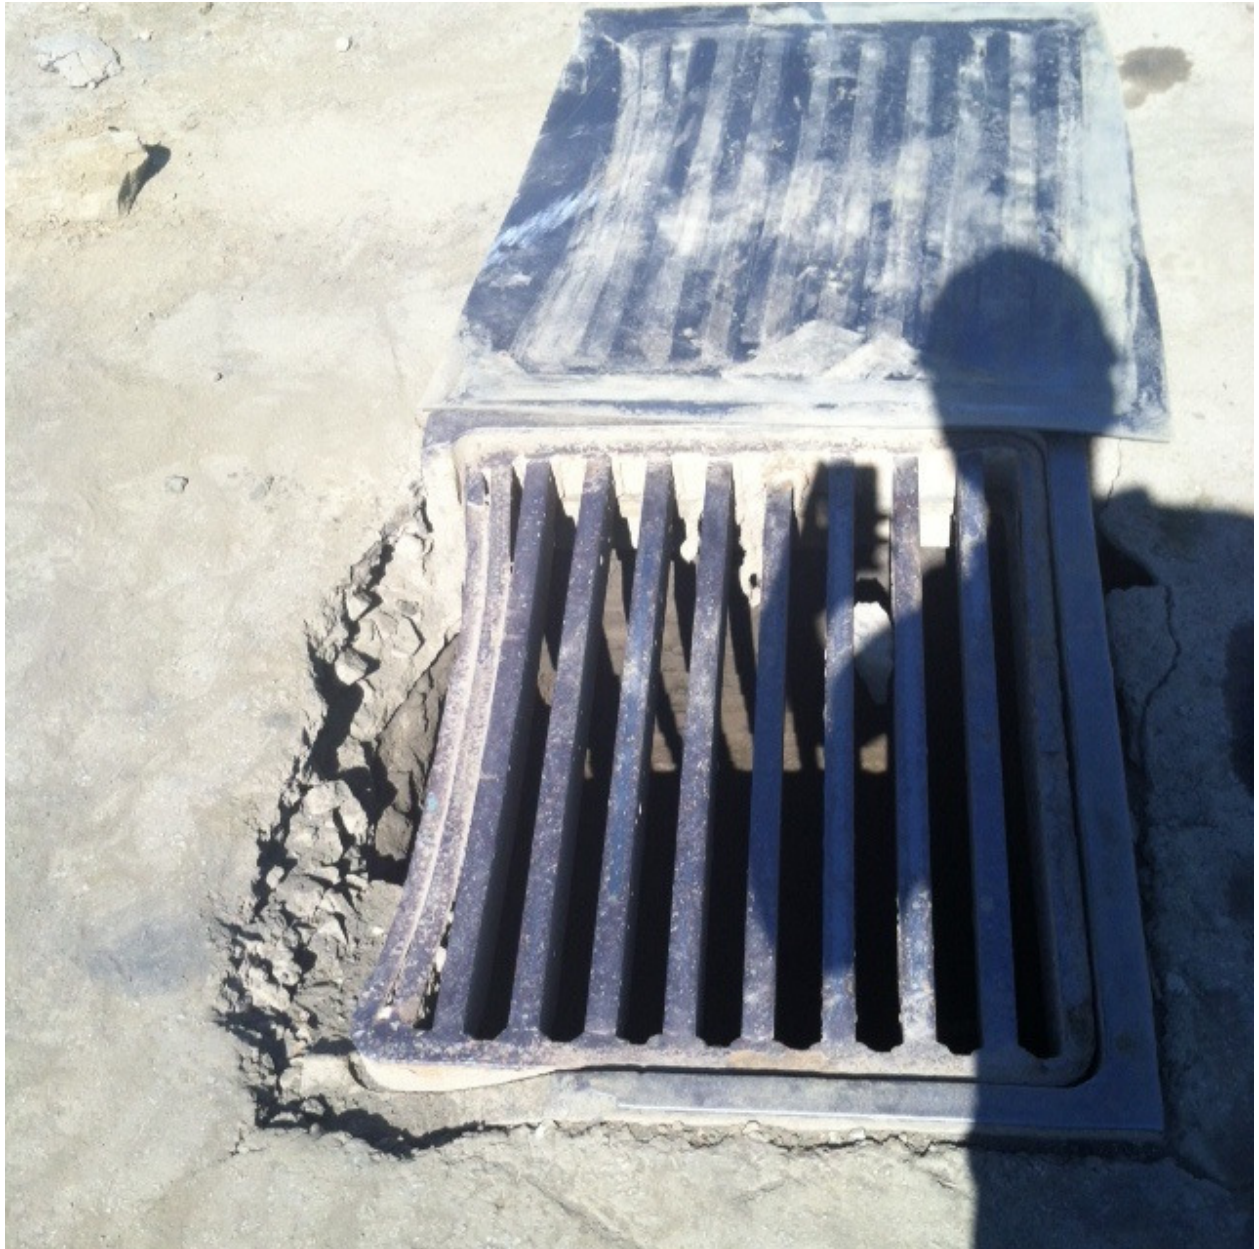
Enclosure 1

- 1) Photograph of cleaned out storm drain
- 2) Photograph of different version of storm drain that has been cleaned out
- 3) Photograph of a cleaned out storm drain without cover
- 4) Photograph of a different cleaned out storm drain without cover
- 5) Photograph of men cleaning the spilled debris inside the hazardous waste drum area
- 6) Photograph of men cleaning the spilled debris marks inside the haz waste area
- 7) GMD SWPPP Training for Managers – Training sign in plus 2 sheets
- 8) GMD SWPPP and SPDES Training for Entire Shipyard – Training sign in plus 6 sheets
- 9) GMD Shipyard Best Management Practices Training Part 1 – Training sign in plus 6 sheets
- 10) GMD Shipyard Annual Dry weather storm drain flow inspection dated 5Sept2014

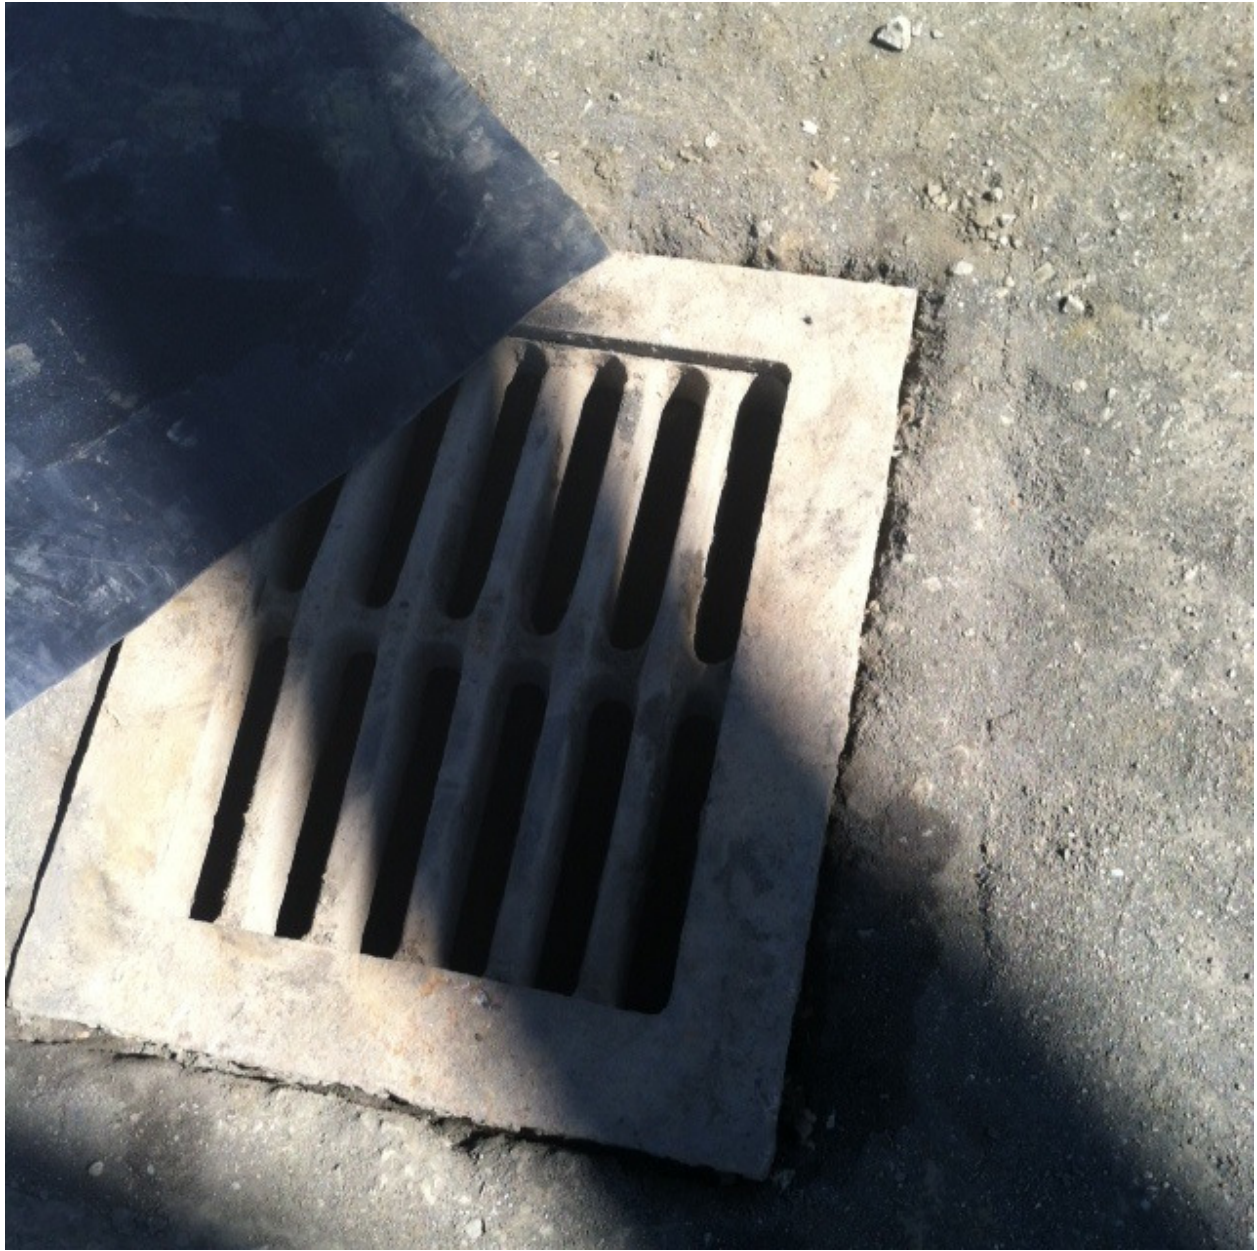
A different drain cover design at GMD. Drain was cleared of all debris.
Enclosure 2

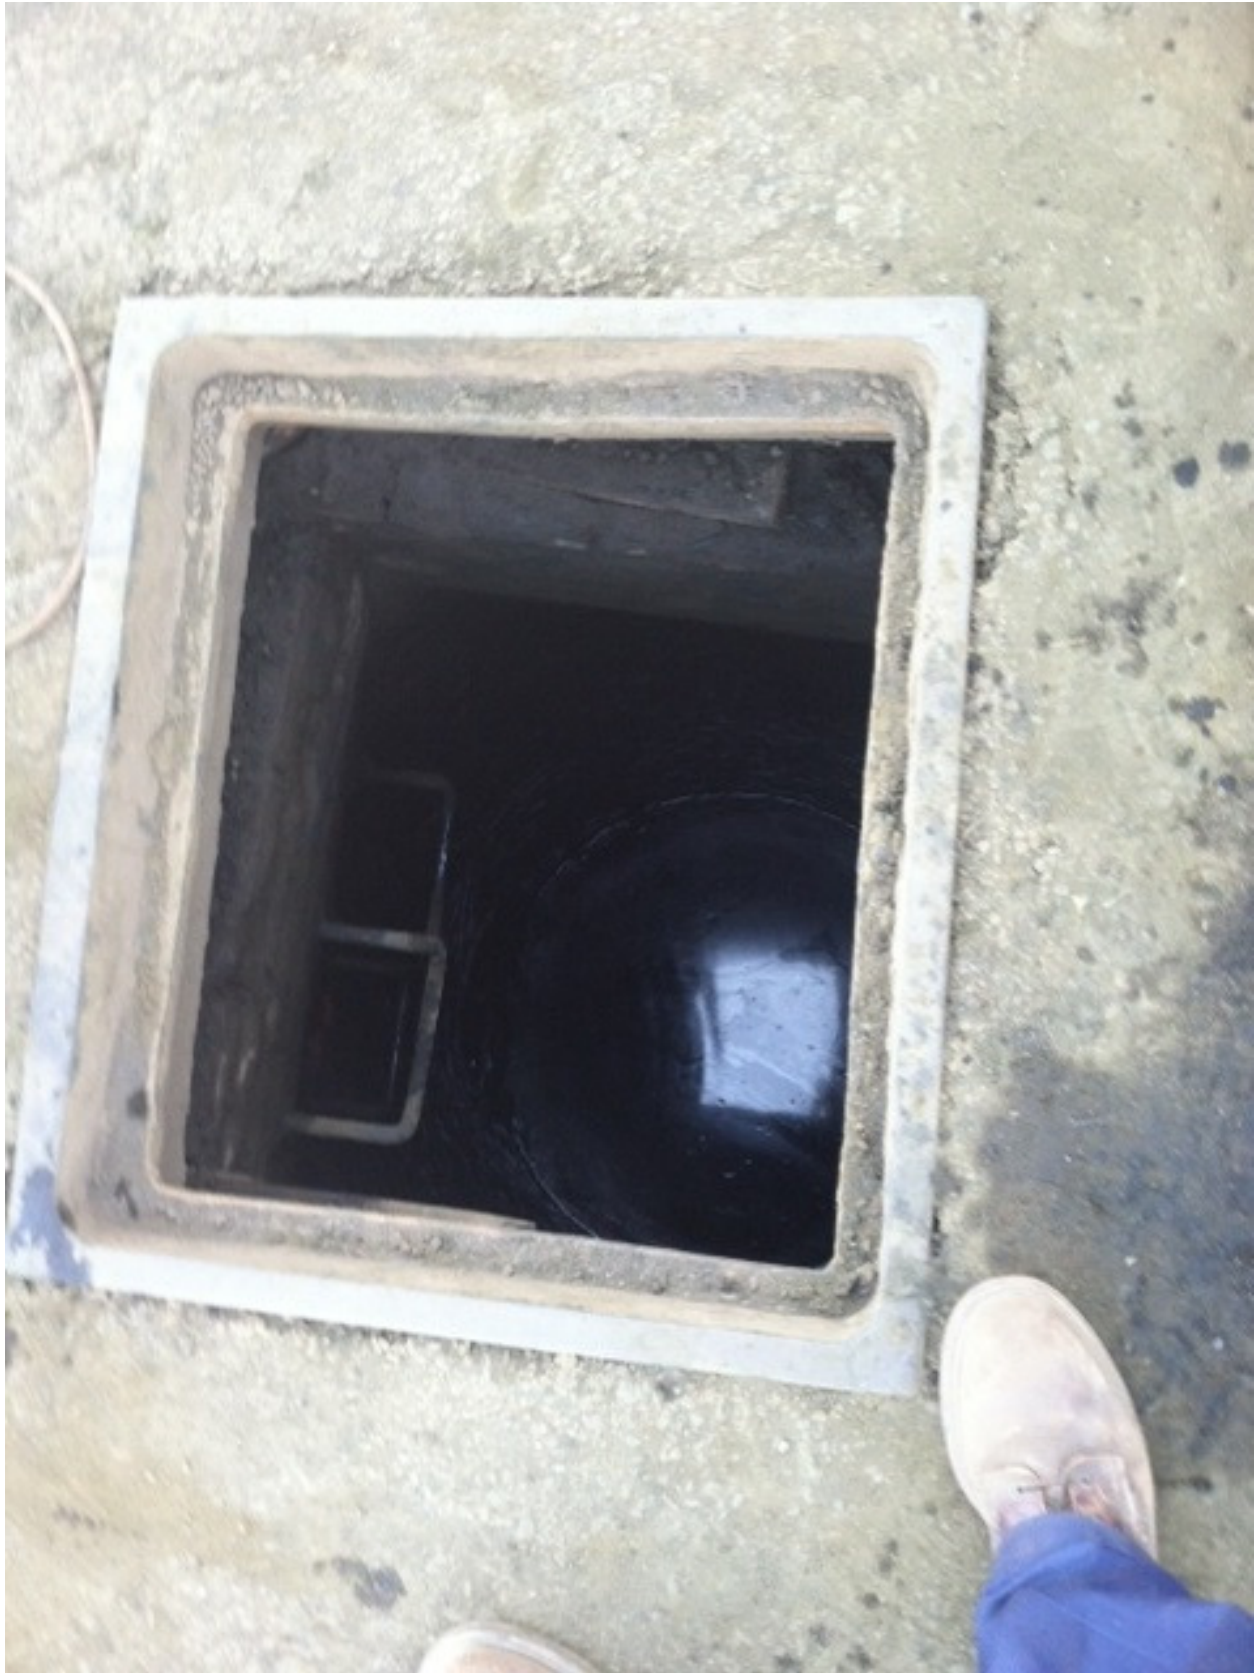
Drain cleared to the bottom - Enclosure 3

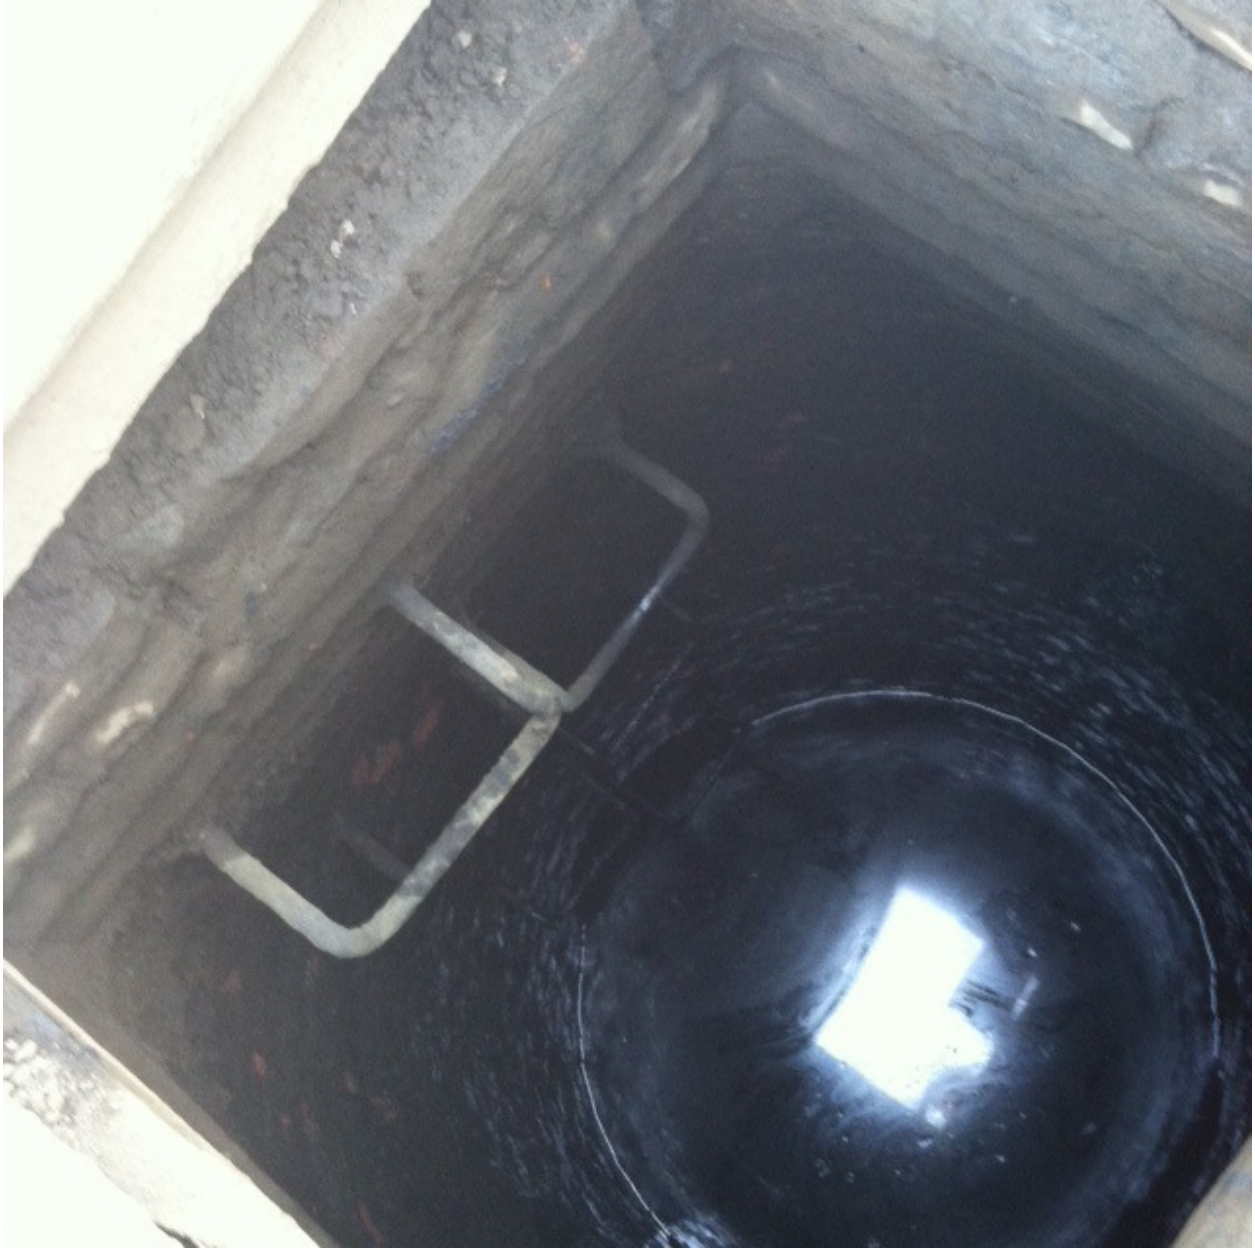
Another drain cleared to the bottom - Enclosure 4

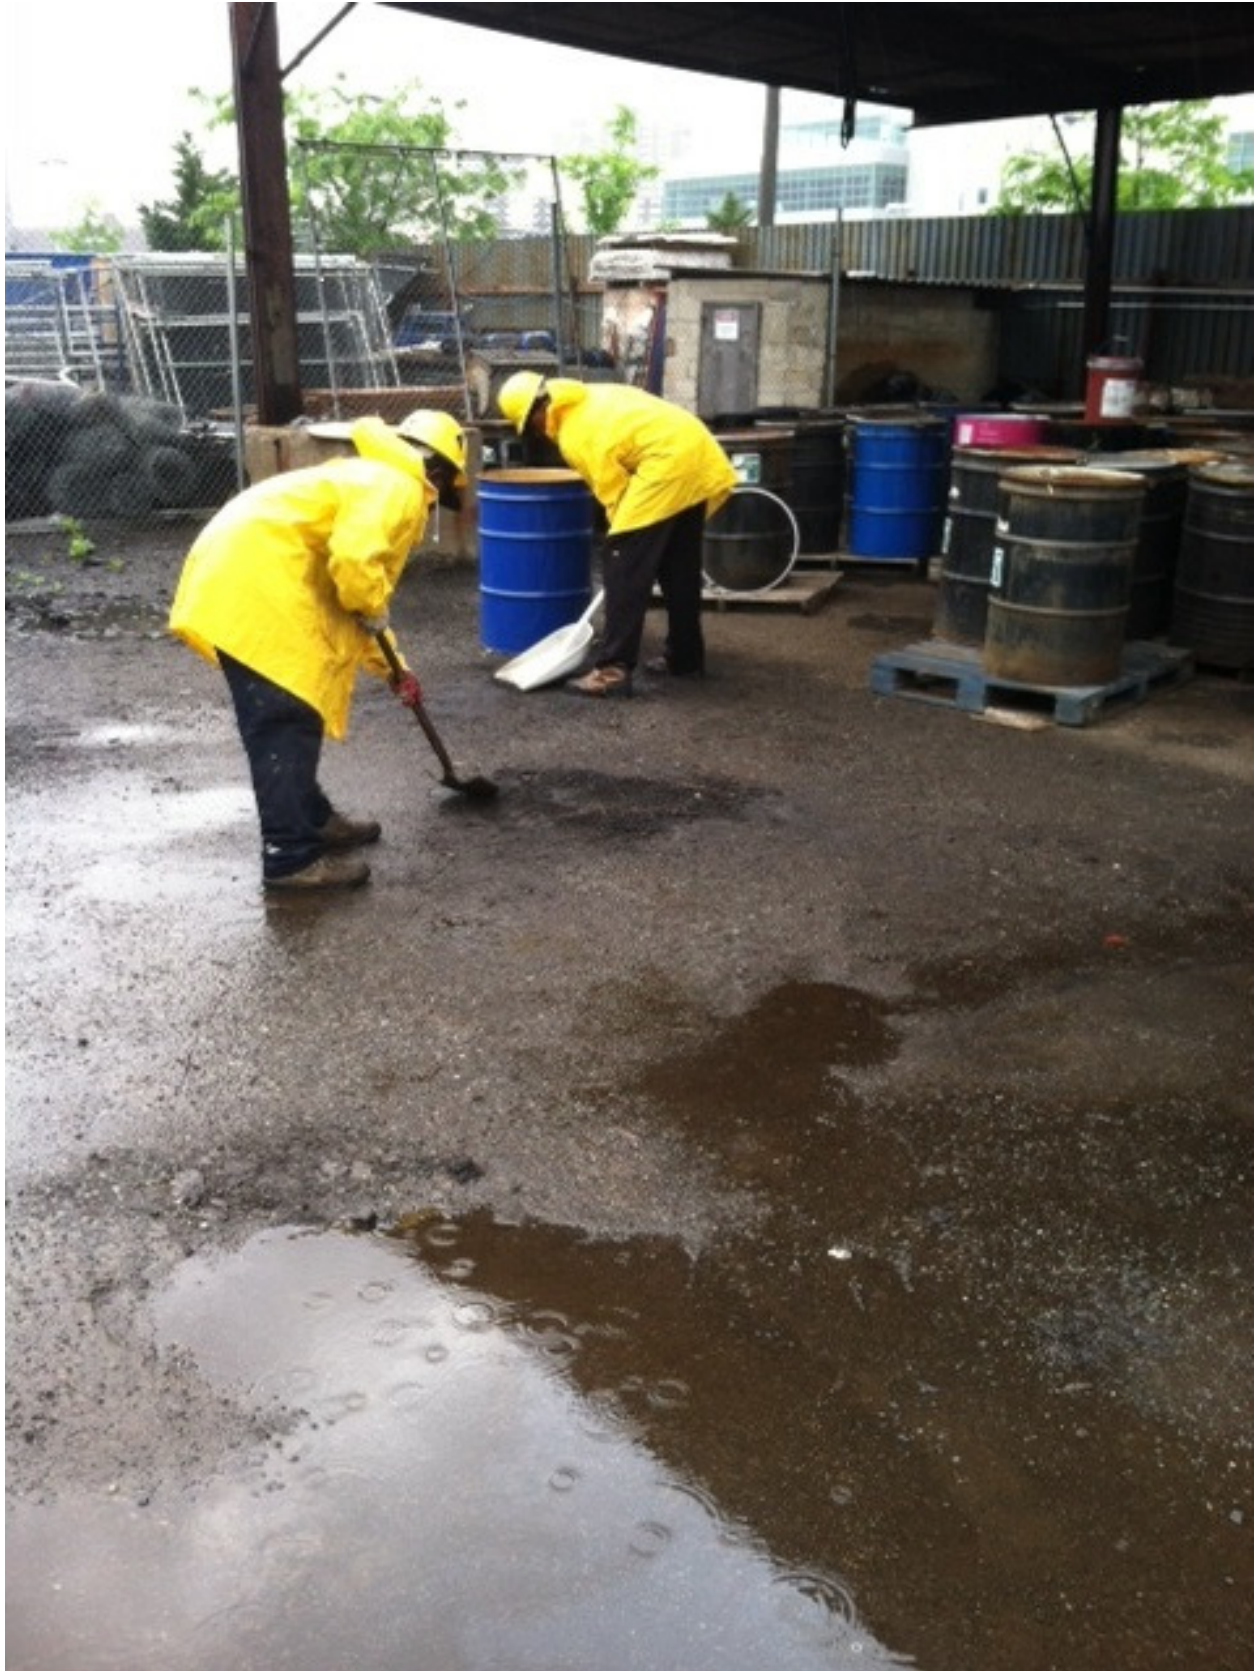
(d) Work to remove the oil spill stains that were located inside the hazardous waste area has taken place. Remnants of the oil spill stains did not come out but efforts have been made to get the stain out. The pooling waters with oil sheens mentioned in (d)(2(and (d)(3) have been cleaned up and oil debris put in drums for disposal as oily waste water and debris. See Enclosure 5 and 6.

Clean up of drum area – enclosure 5

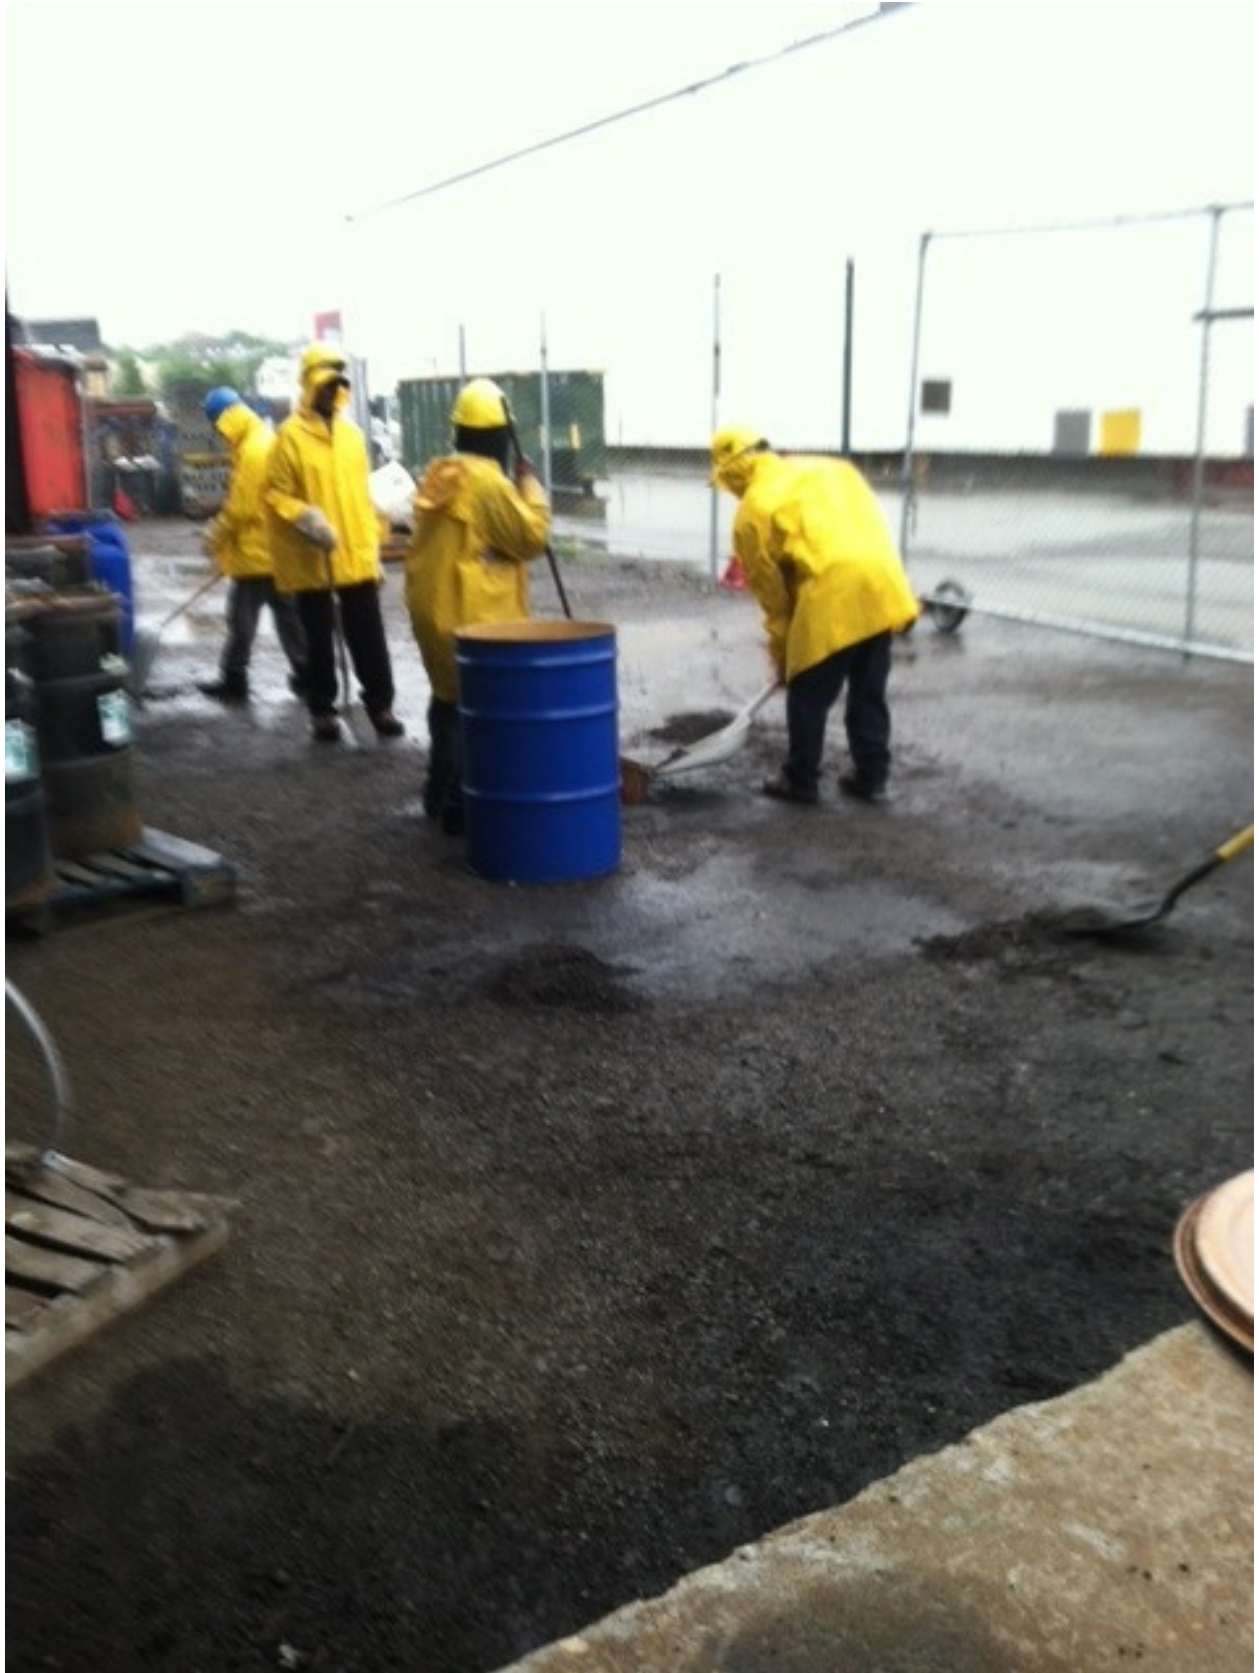
Clean up of drum area – Enclosure 6

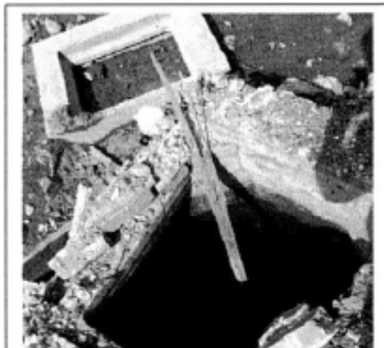
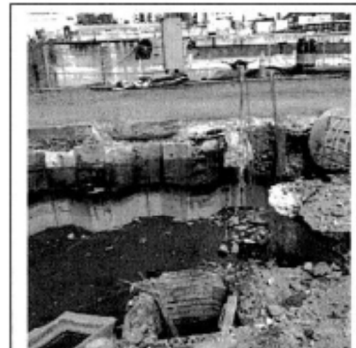
c. The outflow #004 has active construction and has been disturbed. Attached is a picture of what I believe remains of the last storm drain before the discharge. The discharge area has active construction taking place. Past this drain there is water, the entire end of the pier has been removed. See pictures:
